DOI 10.51558/2303-5161.2025.13.13.64

Scientific paper

**ENGINEERING-GEOLOGICAL AND GEOTECHNICAL CHARACTERISTICS OF THE LANDSLIDE AT "CRVENE NJIVE" SITE IN TUZLA**Jasenko Čomić<sup>1</sup>, Ajiša Bedić<sup>2</sup><sup>1</sup>*Dr.sci. Jasenko Čomić, Georad d.o.o.Tuzla, [jasenkocomic@gmail.com](mailto:jasenkocomic@gmail.com)*<sup>2</sup>*Ajiša Bedić, Georad d.o.o.Tuzla, [georadtz@yahoo.com](mailto:georadtz@yahoo.com)***Summary**

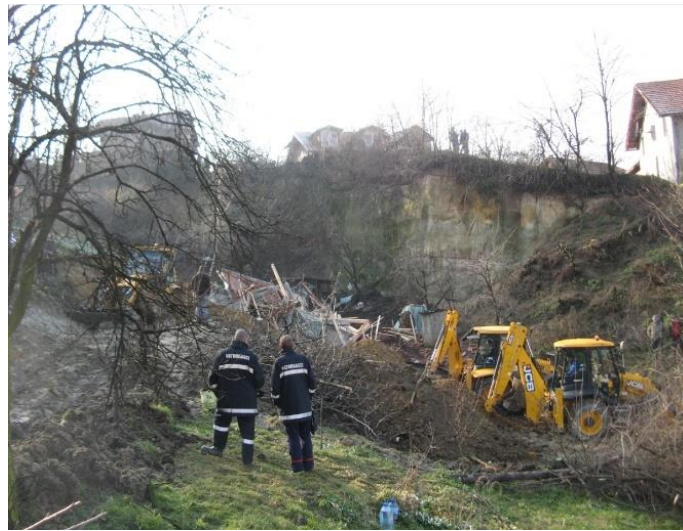
remained with two striking high (8-12 m) and subvertical slopes (west and south) with a slope of 80 to 90° (Figure 1).

Figure 1. Subvertical western slope. (Photo: J. Čomić, 2010).

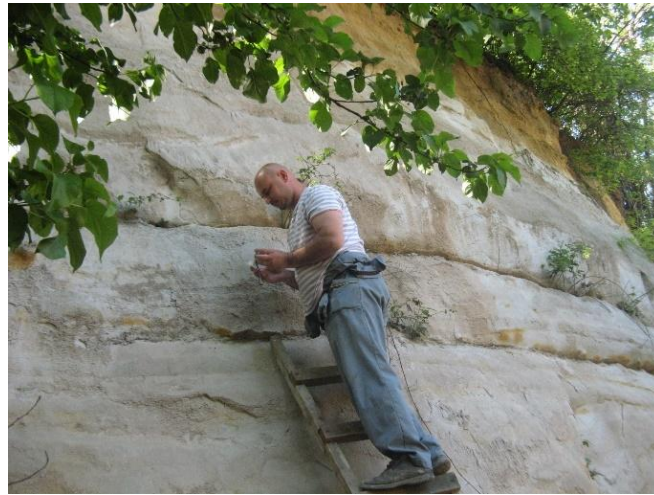
Figure 4. Measurement of elements of the inclination of strata - western slope. (Photo A. Čomić, 2011)

During the engineering geological mapping of the terrain on the open outcrops of sandstone and interlayers of clay, elements of inclination  $300/12^\circ$  and  $312/14^\circ$  were determined. In addition to the measurement of the inclination elements of the layers, the measurement of the inclination of elements of the larger striking cracks in the area of the landslide scar was carried out (Figure 5).

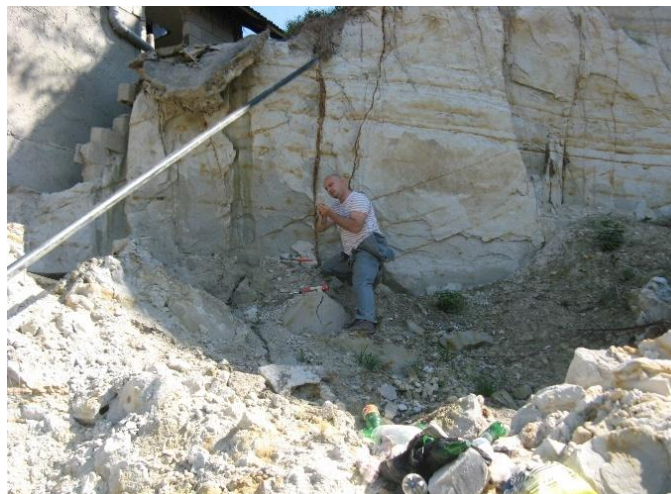
Figure 5. Measurement of crack inclination elements in the landslide scar zone. (Photo A. Čomić, 2011).

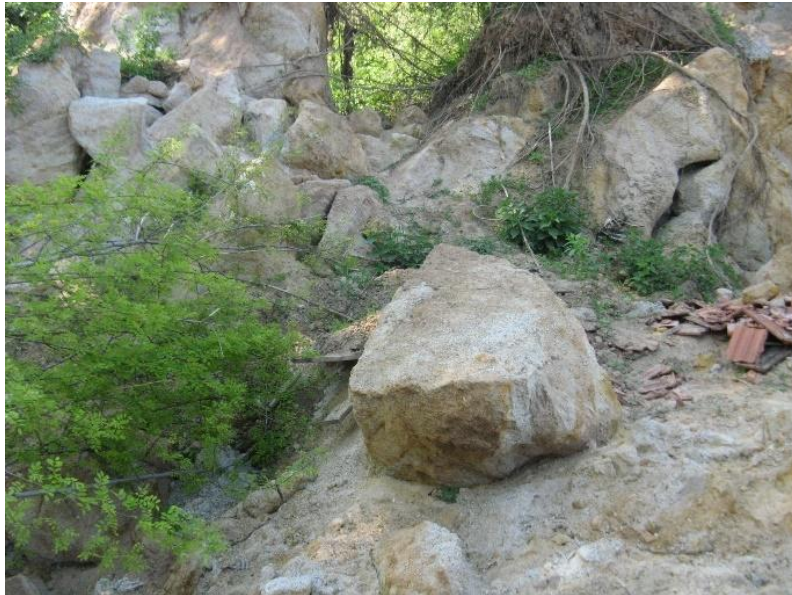
Figure 6. Blocks of detached sandstone. (Photo by J. Čomić, 2011)

Due to the sudden separation of the sandstone mass along the fault, a larger block with a width of about 55 m and a length of about 17 m was torn off, which subsequently broke up into several smaller sandstone blocks of different shapes and volumes (from 1 to more m<sup>3</sup>). Geophysical tests have determined that the depth of the landslide ranges from 10 - 12 m and is related to the depth of the clayey layer (substrate layer of the subfloor coal layer) located under the sandstone. Block tearing off and crushing was carried out along the lower order of cracks in the sandstone. As a subject is a semi-bonded and bonded material (sandstones), as a result of block tearing off along predisposed discontinuities, there was a sudden movement of sandstone blocks towards the foot of the slope where an individual residential building was located what resulted in casualties of 3 people. [10]

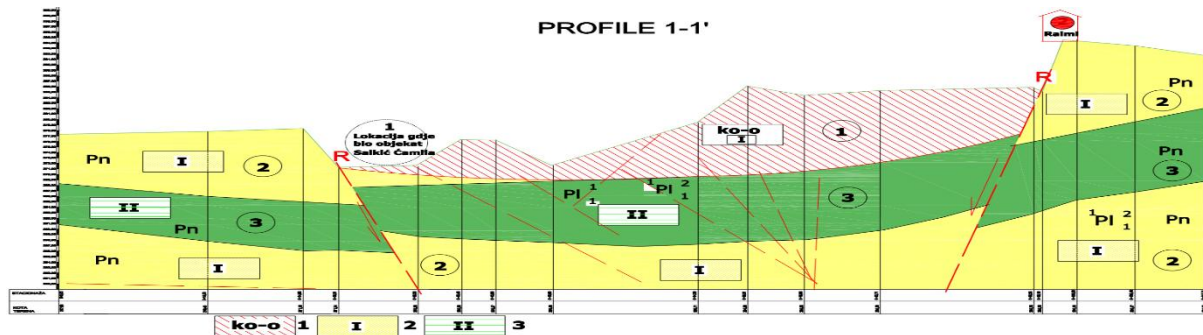
Figure 7. Engineering geological profile 1-1', southern slopes.

environment of variable geotechnical characteristics. In certain landslide zones where large blocks of sandstone are separated, the primary stratification has been preserved. The thickness of the colluvial cover is variable and is shown on engineering geological profiles 1-1', 2-2' (Figures 7 and 8).

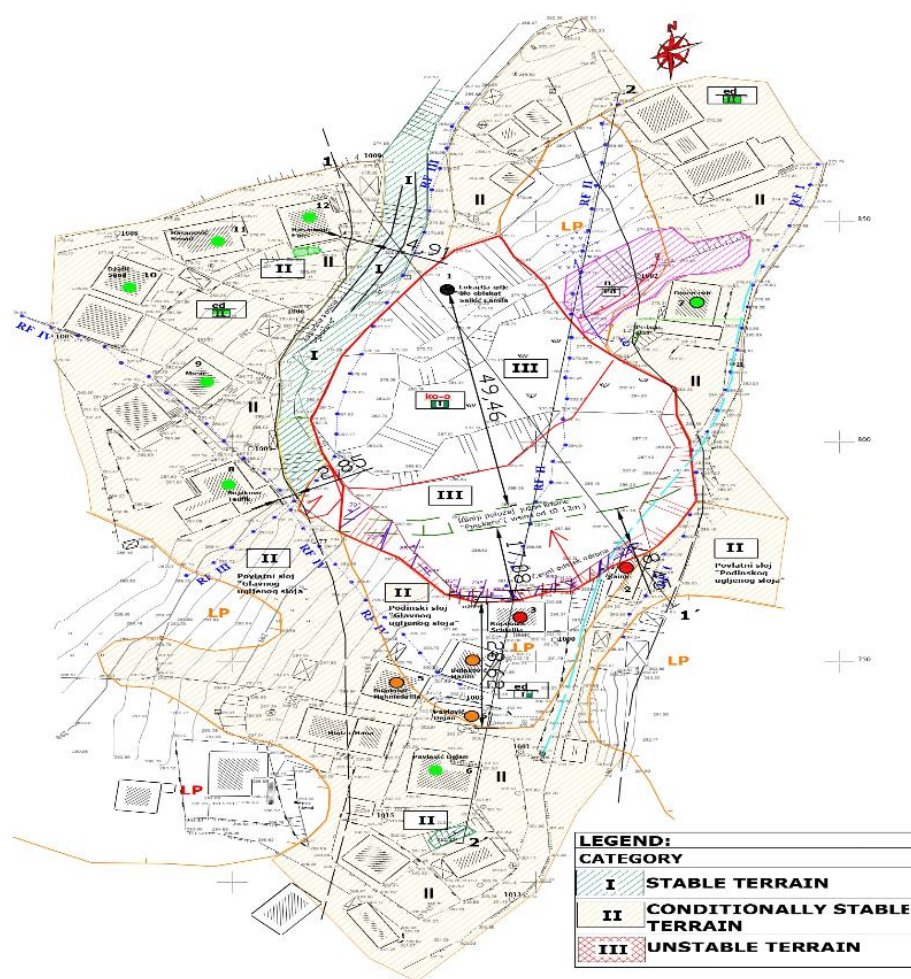
Figure 9. Terrain regionalization according to the degree of stability

This terrain category represents a part of the area affected by the landslide process. The unstable part of the terrain within the researched area occupies an area of 5,416.22 m<sup>2</sup>, which represents 32.37% of the total area of the investigation area, which is 16,734.49 m<sup>2</sup>. In the unstable terrain category, which is clearly defined in terms of space, no new construction or legalization of existing buildings can be carried out due to the possible reactivation of the landslide. Legalization of existing buildings cannot be carried out until the landslide has been completely rehabilitated, under expert supervision and monitoring of the success of the rehabilitation measures. In this part of the terrain any cutting of the terrain or the formation of larger embankments shall not be carried out.

It occupies an area of 10,780.71 m<sup>2</sup>, which makes up 64.42% of the total area of the researched area. With prescribed measures and performed rehabilitation, it can be transferred to the stable terrain category. Legalization of buildings can be carried out only after the rehabilitation of unstable terrain is completed. This terrain category can be transformed into the stable terrain category with prescribed measures.

In the zone of the western slope or left side of the landslide with an area of 537.56 m<sup>2</sup>, the

landslide is not expected to spread, but only to shed of the material, which should be prevented by protecting the slope from the effects of erosion.

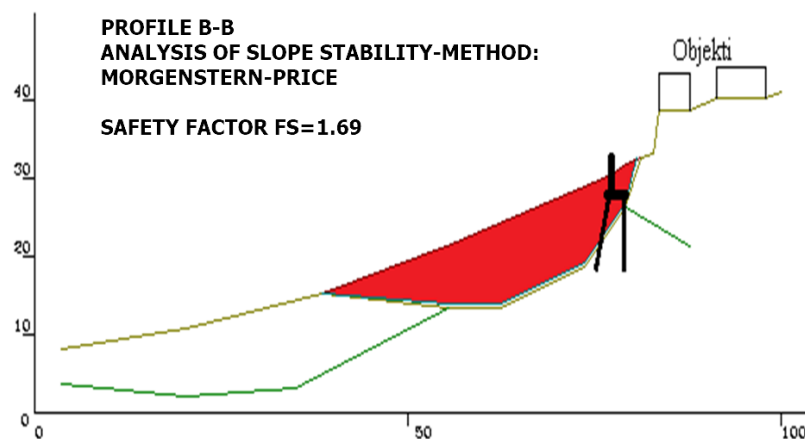
Figure 10. Model for stability analysis (repaired condition), profile B-B'.

The researched area is characterized by a distinguished interaction of natural factors (unfavorable orientation of cracks from the aspect of stability, hydrogeological conditions) and anthropogenic factors (decades of uncontrolled exploitation of sandstone, unplanned construction of buildings, unregulated drainage of rainwater and wastewater, illegal dumpsites, and inadequate and unprofessional implementation of rehabilitation measures at the first signs of instability. Based on the identified causes and vulnerability of the area with regard to (the possibility of landslide spread and further endangerment of residents and buildings), it is necessary to carry out a complete rehabilitation of the terrain, divided into two phases. At the beginning of March 2012, the first phase of the terrain rehabilitation was carried out by constructing a drainage system. The slope stability was increased by constructing a drainage system with the aim of draining flooded soil masses in the zone of flooded geological substrate, controlled drainage by drainage collectors. The first phase of the rehabilitation in the settlement also includes the recultivation of the terrain. The second phase of the rehabilitation is planned to include the construction of a supporting structure (reinforced concrete wall), based on reinforced concrete piers 10.00 m long, arranged in two axes according to the design of the supporting structure, supported in a layer of geological substrate. The safety factor of the repaired slope is  $FS=1.69$  (Figure 10).

After conducting research and zoning the terrain according to the degree of stability, a potential landslide propagation zone of about 28 m in length was defined in the hinterland of the frontal section, where many discontinuities in the sandstone massif were registered. All buildings and their residents located in this part where landslide propagation can be expected to be exposed to the risk of damage and endangerment of life. Ensuring the safety of facilities can only be achieved by implementing comprehensive rehabilitation. After the rehabilitation of the terrain is completed, geodetic monitoring is required [12].
