Scientific paper

TASKS IN TORRENT CONTROL AND DETERMINATION OF THE EROSION COEFFICIENT OF THE TURIJA RIVER BASIN

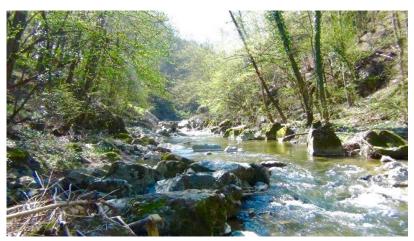
The Turija river basin belongs to the Modrac reservoir basin. The Turija River in its upper and middle course, including its tributaries, is located in a mountainous area. It is characterized by a large drop in the bottom of the natural bed, which results in a high speed of water flow and water power that erodes the banks and carries a huge amount of sediment with its bed to the Modrac reservoir [2].

Figure 1. The bed of the Turija River in its middle course

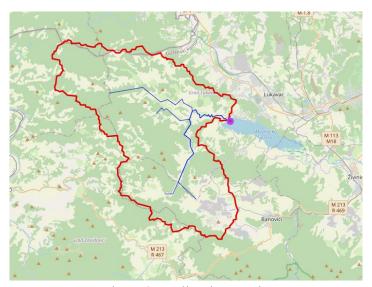
The area of the Turija river basin is about 240.00 km2. It can be said that it belongs to medium watersheds according to the qualification of watersheds in hydrology [2].

Figure 2. Turija River Basin

In the following Figure 2, the catchment area of the Turija River is shown, taken from https://mghydro.com/watersheds/.

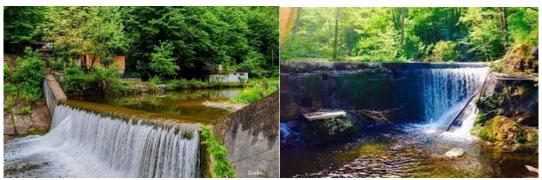
The above-mentioned reinforced concrete dams do not perform their function for the simple reason that they are not maintained, that is, that sediment extraction on the upstream side is not carried out. The reason for this is that the dams were built in inaccessible places and the currently available construction machinery does not have access to clean it. It is important to point out that the aforementioned dams have cleaning openings of 40x40 cm size, but they are not large enough to clean the huge amount of sediment behind the dam.

Figure 3. Dam on Turija river

Figure 4. Dam on Brijesnica river

geomechanical research. The only two dams that still exist today are the dam on the Turija River and the dam on the Brijesnica River, which is a tributary of the Turija River.
