DOI 10.51558/2303-5161.2025.13.13.64

Scientific paper

**ENGINEERING-GEOLOGICAL AND GEOTECHNICAL CHARACTERISTICS OF THE LANDSLIDE AT "CRVENE NJIVE" SITE IN TUZLA**Jasenko Čomić<sup>1</sup>, Ajiša Bedić<sup>2</sup><sup>1</sup>*Dr.sci. Jasenko Čomić, Georad d.o.o.Tuzla, [jasenkocomic@gmail.com](mailto:jasenkocomic@gmail.com)*<sup>2</sup>*Ajiša Bedić, Georad d.o.o.Tuzla, [georadtz@yahoo.com](mailto:georadtz@yahoo.com)***Summary**

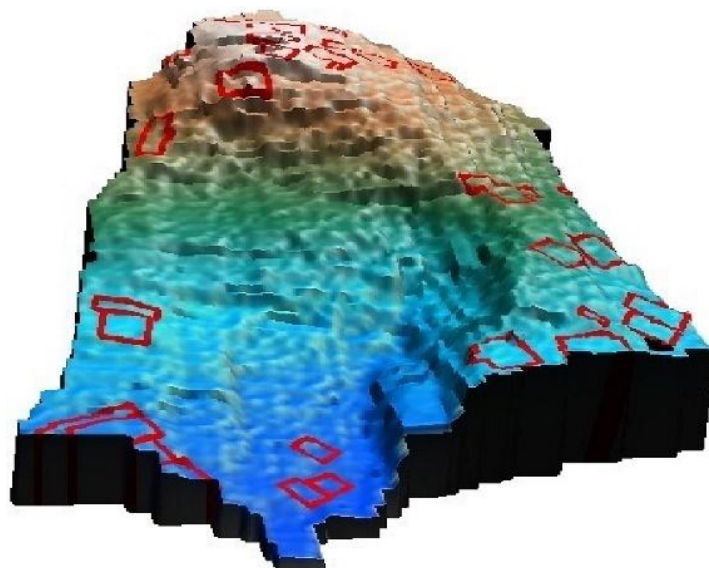
Figure 2. 3D model of the terrain at the site "Crvene Njive"

The average absolute elevation of the terrain in the hinterland of the southern slope was about

300.0 m.a.s.l., and at the foot, where the individual residential building was destroyed, 273.0 m.a.s.l. Figures 2 and 3 show models of terrain and buildings in the research area.
