#### MERCURY (HG) SOIL AND GROUNDWATER ASSESSMENT AT HAK 1, CHEMICAL INDUSTRIAL COMPLEX, TUZLA, BOSNIA & HERZEGOVINA

#### UNIVERSITY OF TUZLA

#### FACULTY OF MINING, GEOLOGY AND CIVIL ENGINEERING

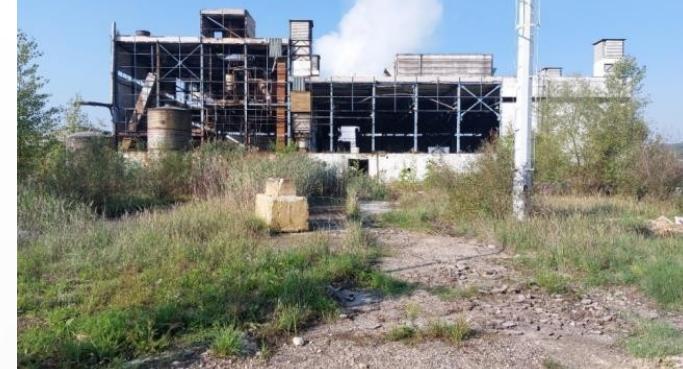
# ELECTROLYSIS PLANT

- CHLORINE, LIME, AND PROPYLENE WERE USED AS BASIC RAW MATERIALS FOR THE PRODUCTION OF PROPYLENE OXIDE.
- CHLORINE PRODUCTION ITSELF WAS CARRIED OUT IN THE ELECTROLYSIS PLANT, AND A CERTAIN AMOUNT OF HCL ACID AND NAOH ALKALI WAS CREATED AS A SIDE PRODUCT FROM THIS PLANT.
- ELECTROLYSIS REQUIRED A LARGE AMOUNT OF SALT WATER AND ELECTRICITY.
- MERCURY CELLS WERE USED IN THE PROCES OF NACL DISSOCIATION.
- BASED ON AVAILABLE DOCUMENTATION 4 TONNES OF MERCURY WERE LOST ANNUALY ON AVERAGE DUE TO LEAKAGES. WHICH IS A SIGNIFICANT ENVIRONMENTAL PROBLEM.

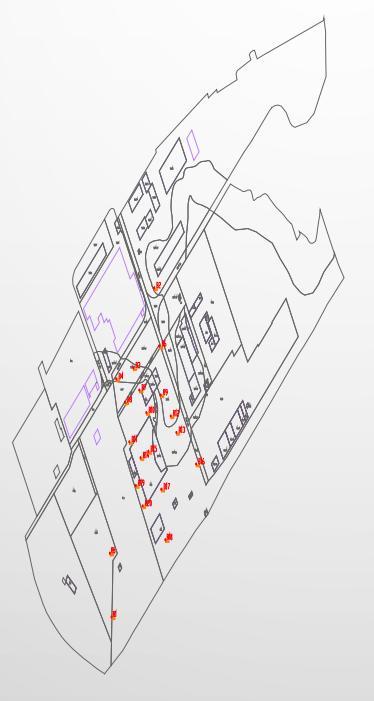
# DRILLHOLES POSITION- FINAL LAYOUT

Position of drillholes adapted to site conditions (underground installations, concrete plates, etc)

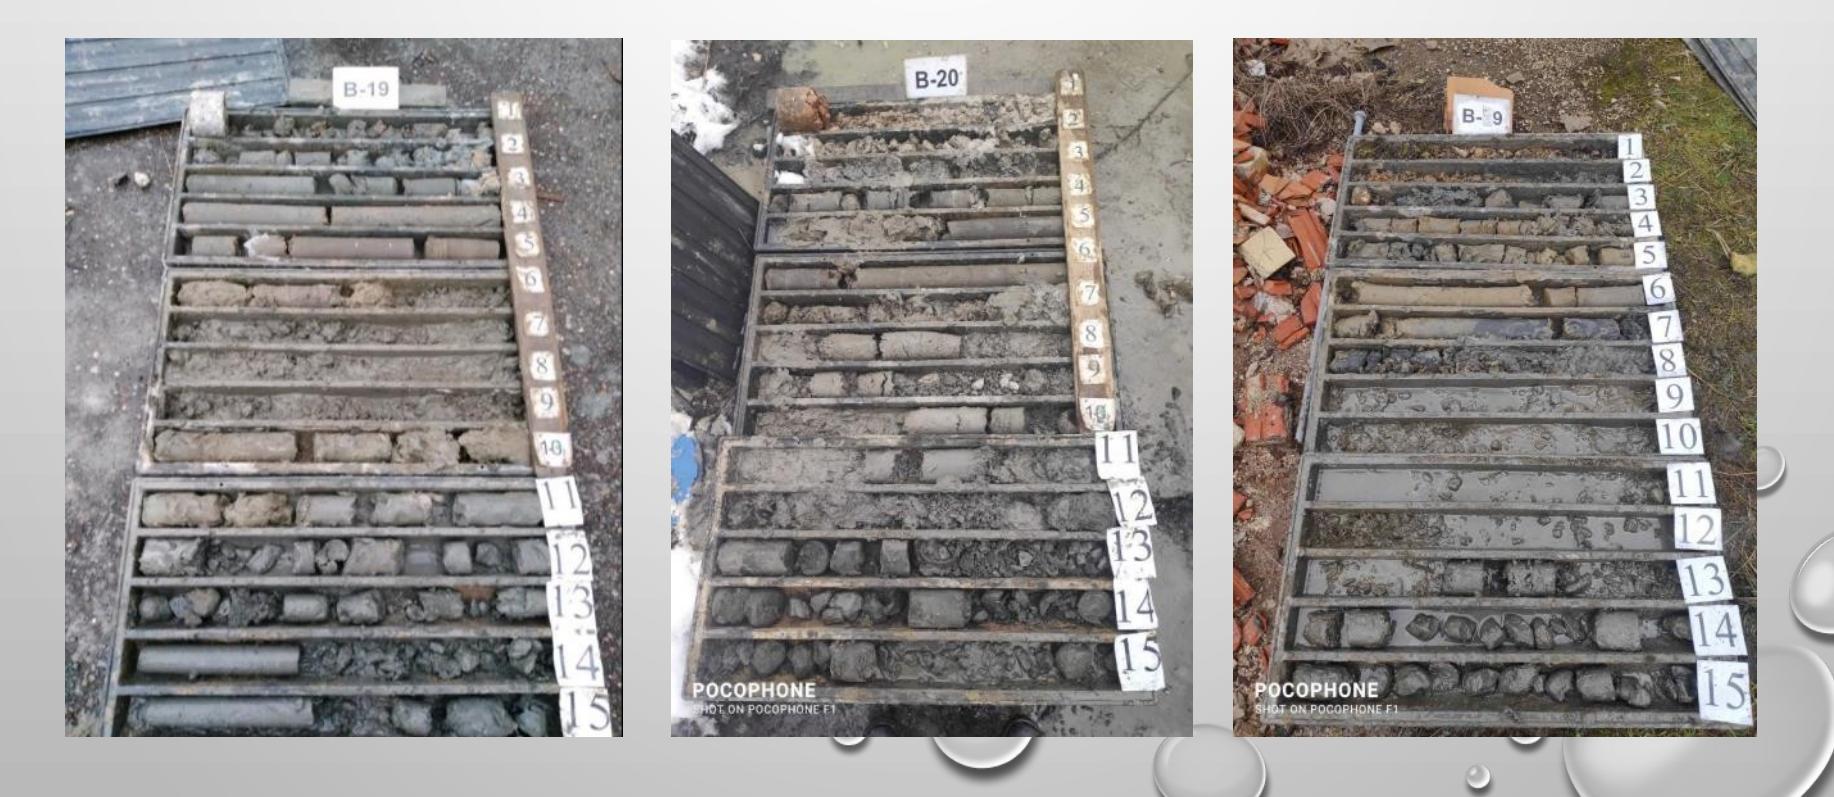
### **DRILL CORES**

- 19 drillholes completed (total 280 m')
- Piesometer construction installed in 5 drillholes
- Drilling of plant foundation and concrete sampling perfomed from floor plates, foundation and plant construction items.

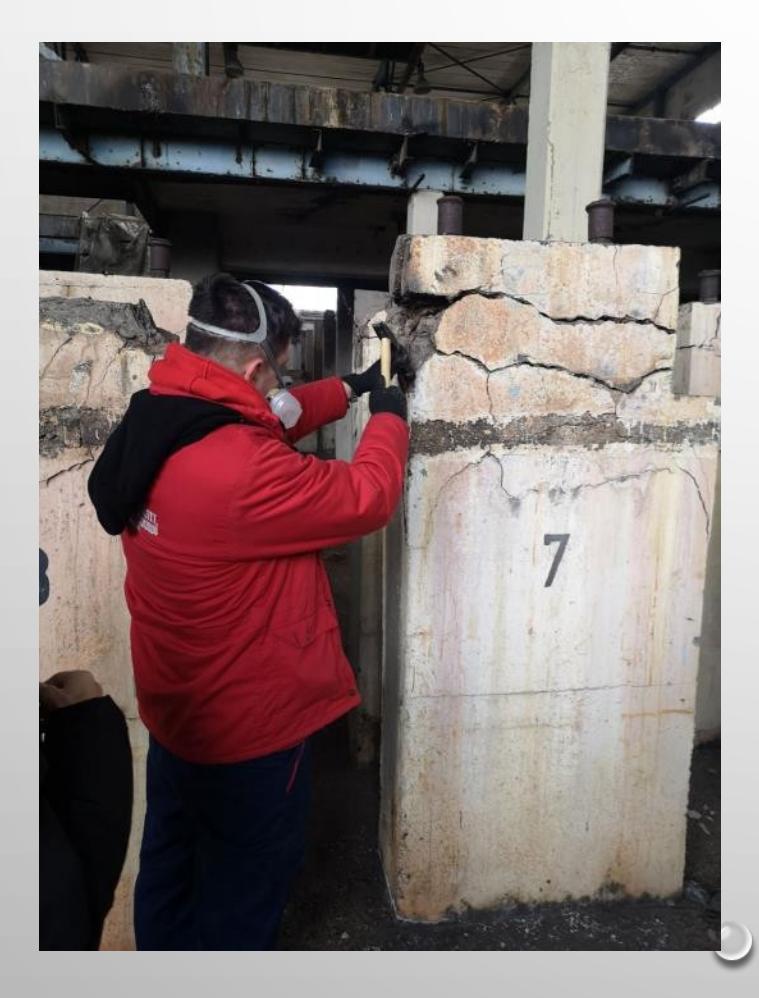
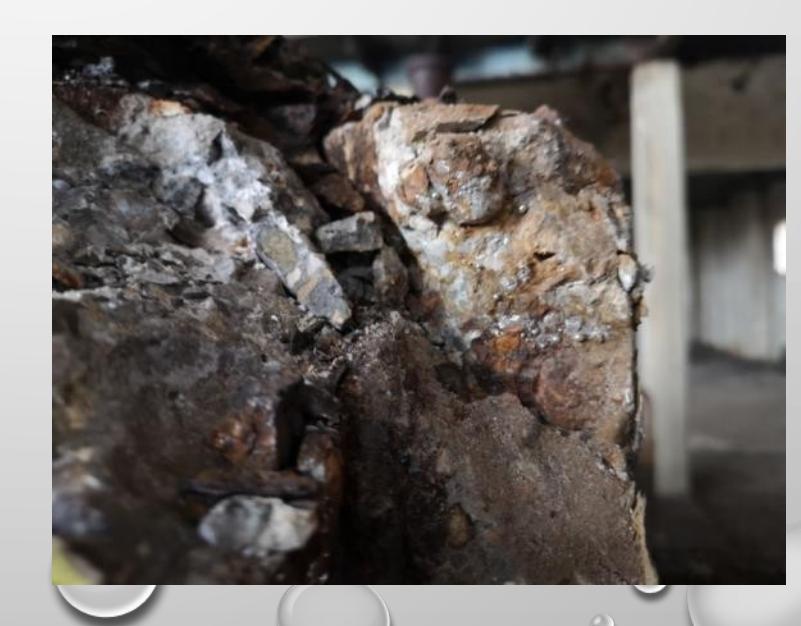
## SAMPLING IN THE ELECTROLYSIS PLANT

After excavating the floor and material from the concrete pillars where mercury cells were situated at the premise of the hall of electrolysis plant, the collection of drops of elemental mercury was noticed which indicates large concentration of mercury in the concrete. Therefore, the collection of samples was not possible due to concentration of Hg in liquid elemental form that is mobile.
